Manhole Inspection Summary

Manhole # S61O__004MH

Insp Date: **4/29/08 9:40 AM**

Location Address: **5500 Interstate Ave.**

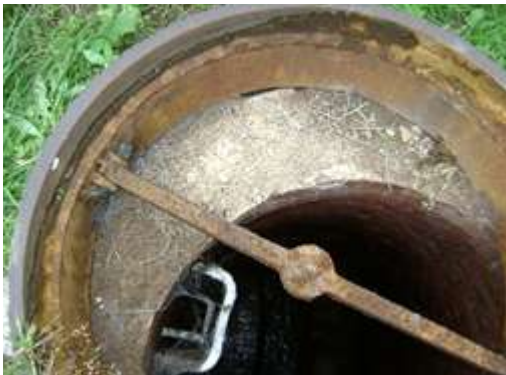
Defect 1

Offset: **8** (in.)

Condition: ☐ Sound ☒ **Cracked** ☐ Leaks

Offset frame

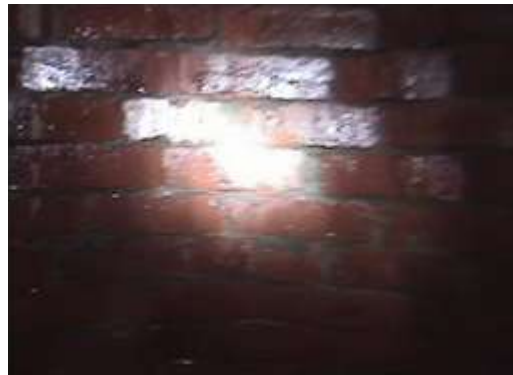
Defect 2

Infiltration: ☐ None ☐ Joint ☐ Cracks ☒ **Mortar** ☐ Roots ☐ Wall

Infiltration

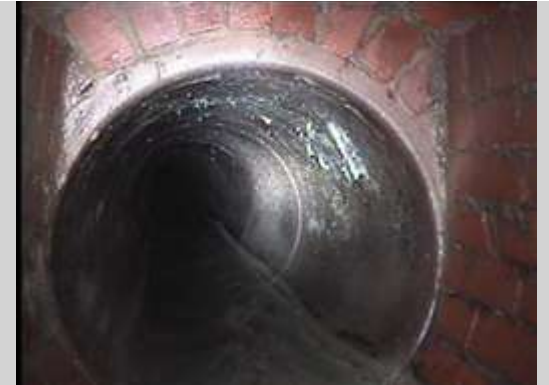
12 O'Clock Outflow

21 in. Circular Gravity Sewer
Pipe Out @ 12 O'Clock

Pipe Height: **21.6** (in.) Rod and Bar (Angled)
Pipe Material: **Clay** ☐ Pipe Lined
Invert Depth: **17.00** (ft.) Flow Characteristics: **Fast**
Deposits: ☒ None ☐ Mud ☐ Sludge ☐ Debris ☐ Grease
Silt Depth: (in.) Deposits Extent:
Infiltration: **None** Pipe Seal Cond: **Sound**

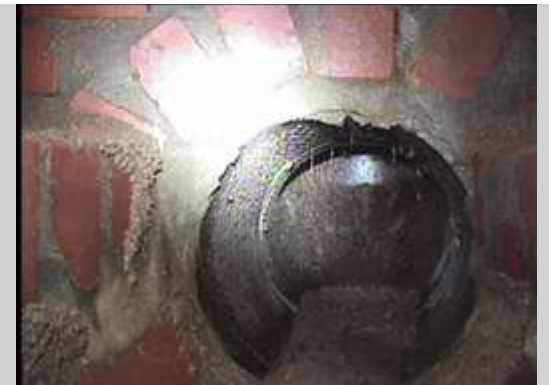
3 O'Clock Inflow

10 in. Circular Gravity Sewer
Pipe In @ 3 O'Clock

Pipe Height: **9.6** (in.) Rod and Bar (Angled)
Pipe Material: **Clay** ☐ Pipe Lined
Invert Depth: **15.83** (ft.) Flow Characteristics: **None**
Deposits: ☒ None ☐ Mud ☐ Sludge ☐ Debris ☐ Grease
Silt Depth: (in.) Deposits Extent:
Infiltration: **None** Pipe Seal Cond: **Sound**

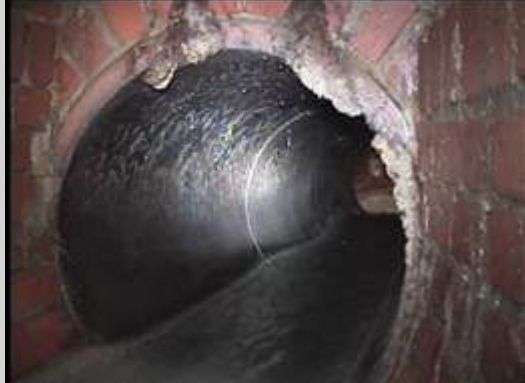
6 O'Clock Inflow

21 in. Circular Gravity Sewer
Pipe In @ 6 O'Clock

Infiltration: **None** Pipe Seal Cond: **Sound**
